Seismic Retrofit and Rehabilitation of the Million Dollar Bridge

Tim Ingham

Million Dollar Bridge

Located near Cordova, AK

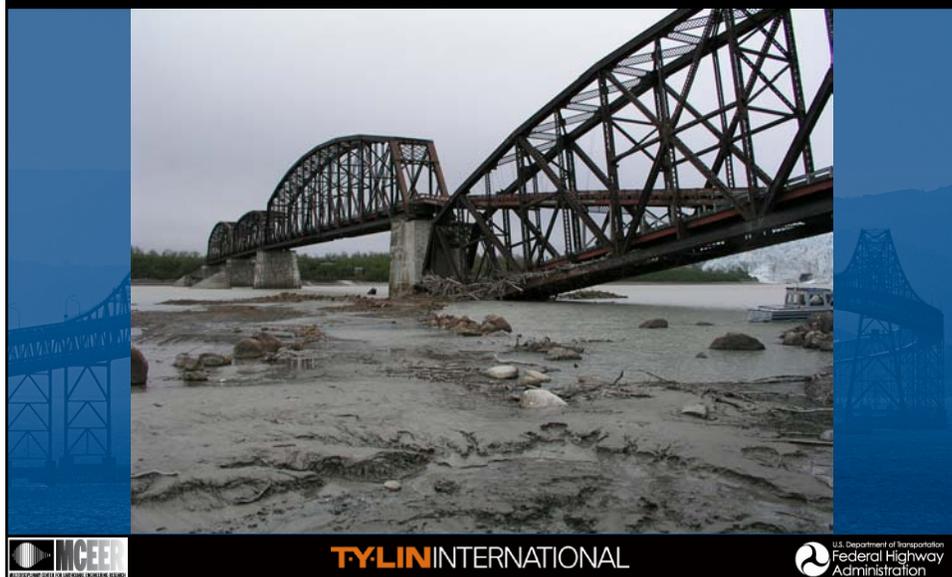
1964 Earthquake Damage

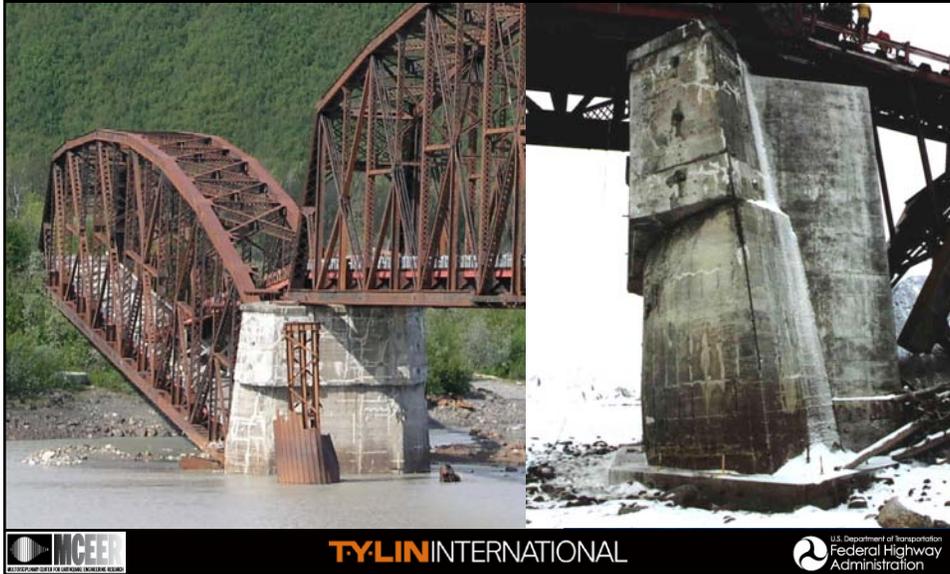
1964 Earthquake Damage

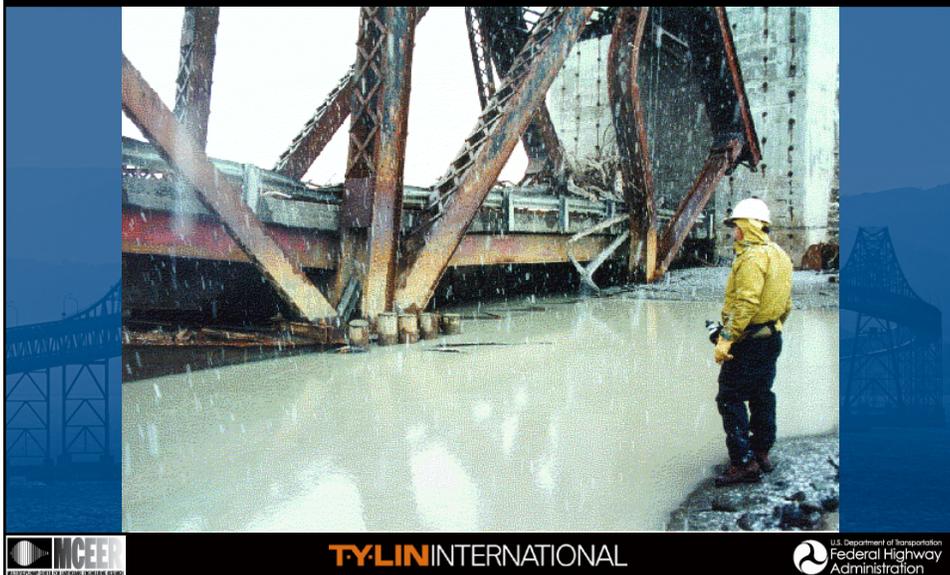
1964 Earthquake Damage (Span 4)

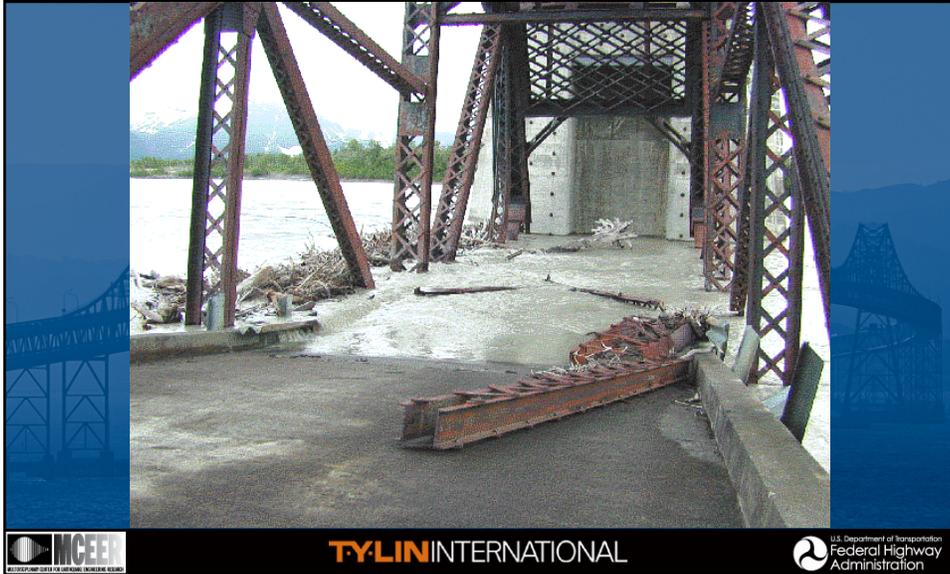
1964 Earthquake Damage (Span 4)

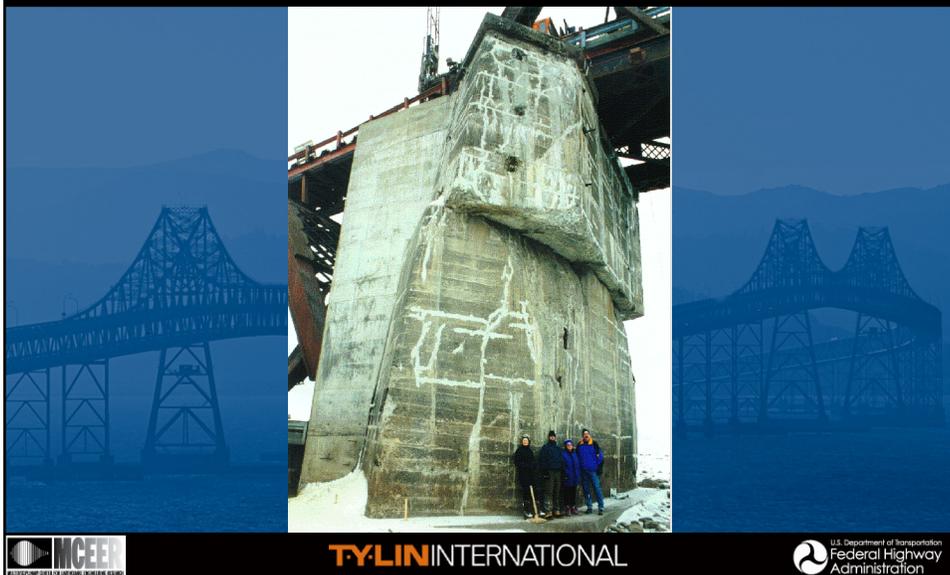
1964 Earthquake Damage (Pier 3)

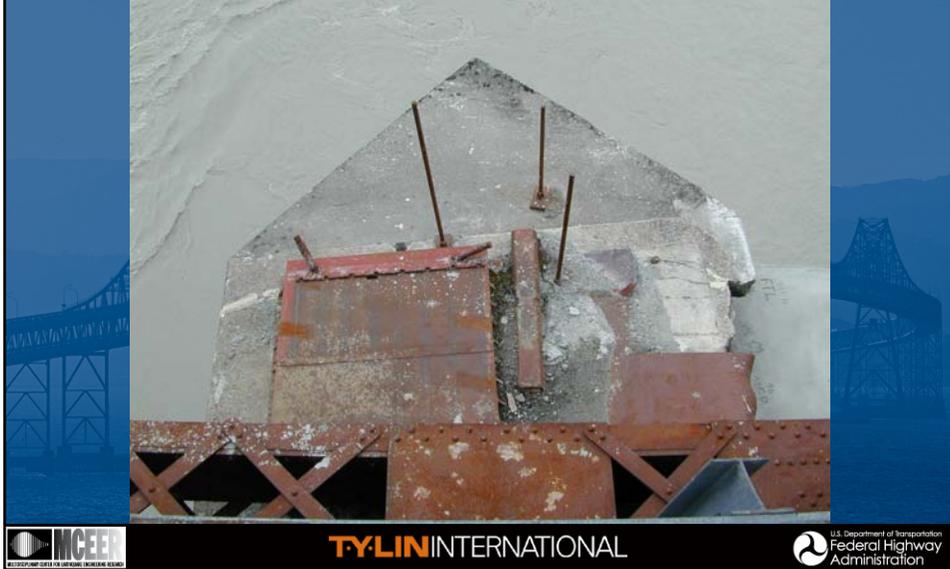
1964 Earthquake Damage (Pier 3)

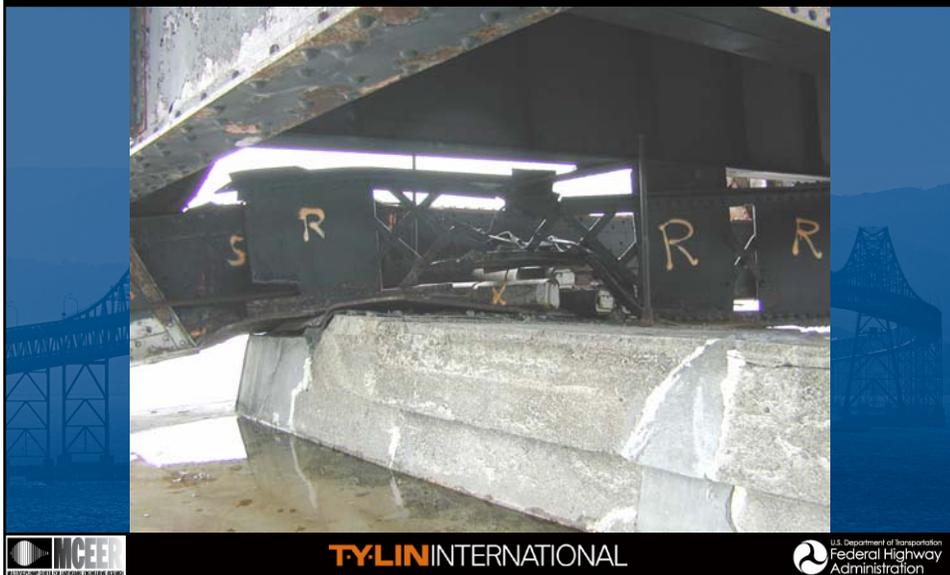
1964 Earthquake Damage (Span 3)

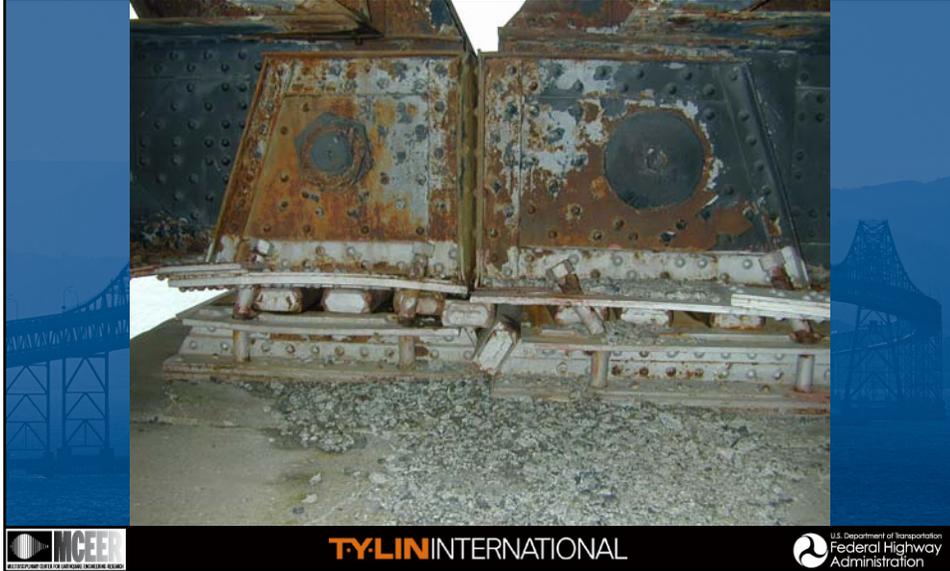
1964 Earthquake Damage (Pier 1)

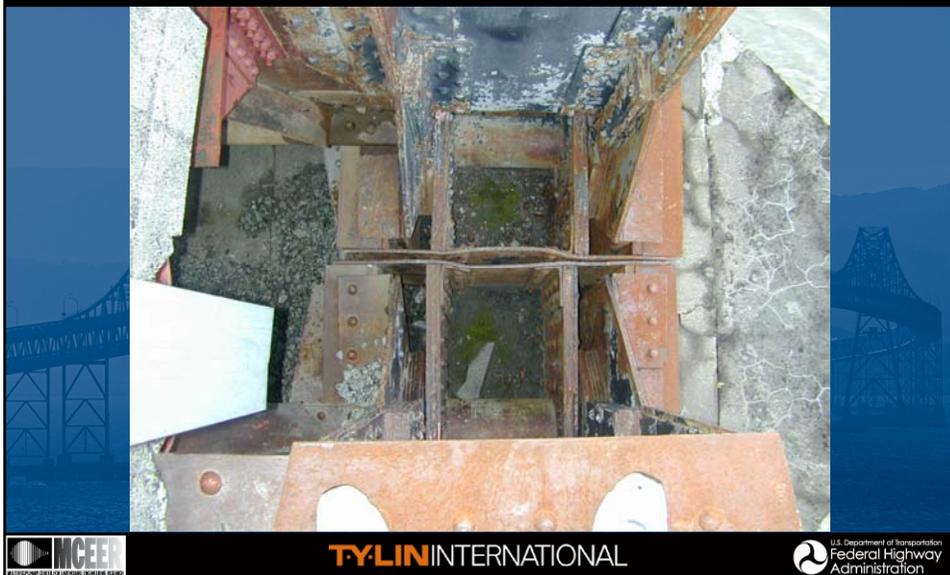
1964 Earthquake Damage (Pier 1)

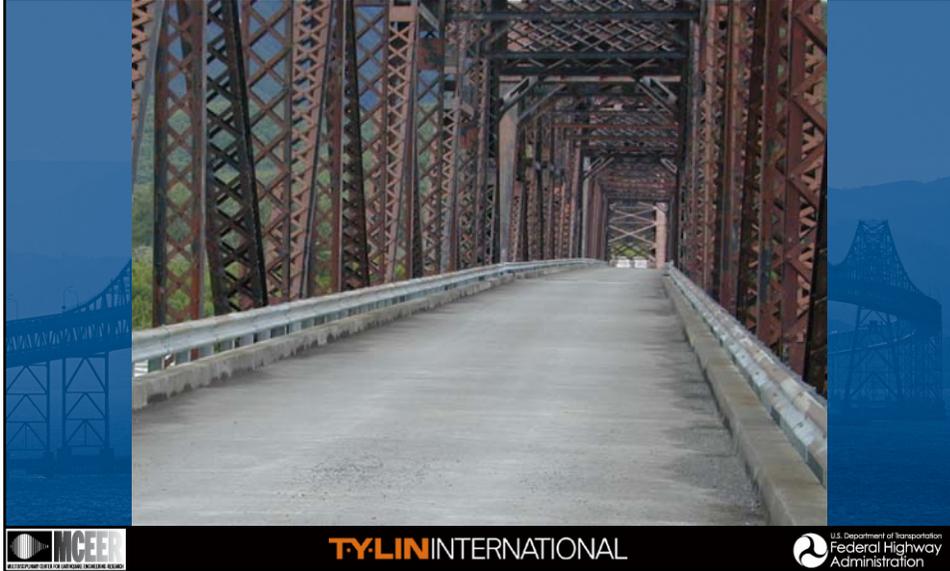
1964 Earthquake Damage
